BIOLOGICAL SAFETY EVALUATION  
OF A COMMERCIAL  
VACCINE PRODUCTION LABORATORY

TECHNICAL REPORT 65

Industrial Health and Safety Division  
DIRECTORATE OF INDUSTRIAL HEALTH AND SAFETY

A contract was awarded to National Drug Company at Swiftwater, Pa., a division of Richardson-Merrell, Inc., by the U.S. Army Medical Unit to develop and produce vaccines for use in humans. The type of vaccines produced is to be governed by the U.S. Army Surgeon General. Among many other problems associated with vaccine production for human use is the ever-present problem of occupational illness among laboratory personnel. In order to control the potential hazards to workers, the building was designed, constructed in 1962-1963, and equipped in accordance with presently acceptable design features for infectious disease laboratories. However, equipment designed and built with what appears to be desirable features is not necessarily biologically safe. The assistance of Industrial Health and Safety Division, Fort Detrick, Maryland, was obtained to locate and evaluate the hazards of working with pathogenic microorganisms.

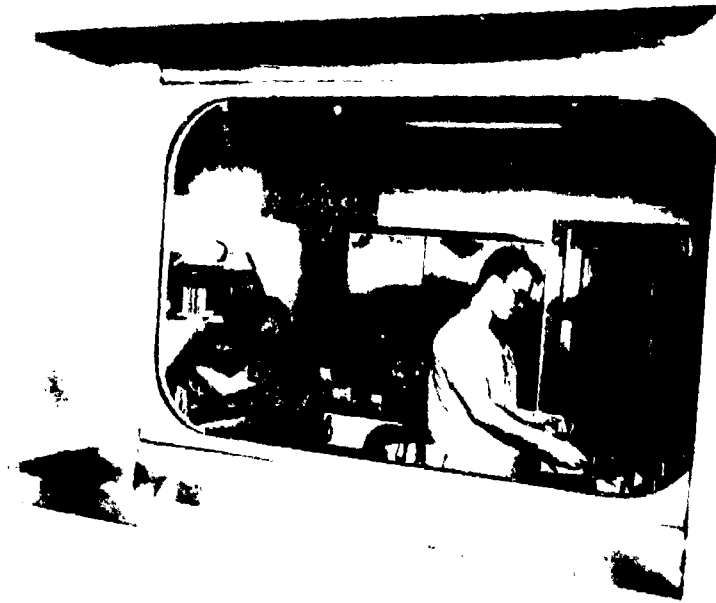
Figure 3. General Floor Plan.

Clean corridors surround each suite on three sides (Fig. 3). Viewing windows to each laboratory room face the corridors (Fig. 4) and are used to observe cultures, animals, and equipment and for routine fire inspections. Two through-the-wall autoclaves and a UV pass box (Fig. 5) are centered in each suite and connect with the interior corridor that serves as a support area for all suites (Fig. 6). Intercommunication is available between the service area and suite and between the suite and air-lock areas located on the end of each suite. A communication page system is interconnected with the telephone and a centrally located public address system.

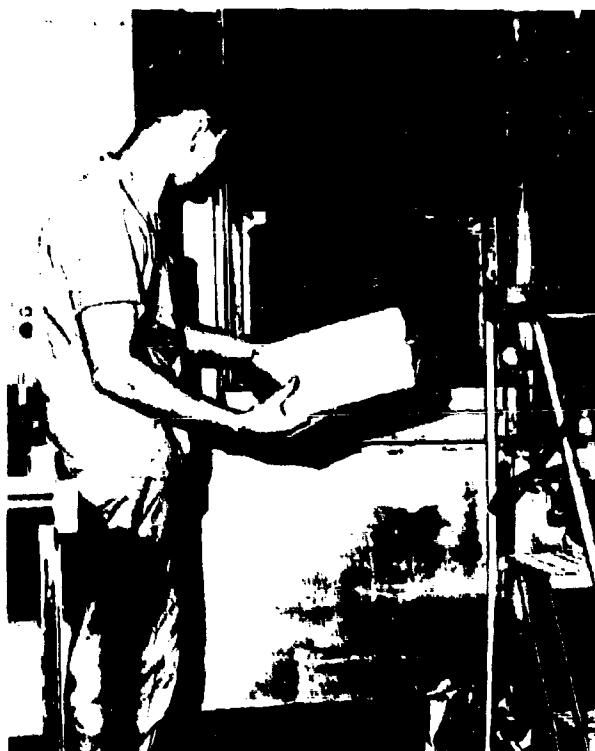
Figure 30. Refuse Incinerator.

To assess any biological hazards associated with charging and burning contaminated waste materials, three 1-hour slit samplers were operated in the charging room of the Suite 4 incinerator (Fig. 30). One sampler was placed on a ladder (Sampler A) and one on a box (Sampler B) to sample the air at the breathing level of a person standing or bending to pick up material to be placed in the firebox. The third sampler was placed on the floor (Sampler C), and a fourth was located in the hallway (Sampler D) near the charging room door. All of the plastic plates containing S. marcescens and E. subtilis that had been used in the first 3 days of biological testing were used as the waste material in this test. It was weighed and placed in three no. 10 kraft bags. The bags weighed 2737, 2705, and 1967 grams.

A 10-minute control sample was taken with each sampler before testing began. The paper bags were carried into the charging room, the door was closed, and the bags were placed on the floor. The foreburner was turned off (this is standard operating procedure) to prevent flashback from the burner and excessive heat gain within the charging room). The guillotine door to the firebox was raised, at which time a slight negative air pressure was noted on the firebox. Next, the three bags were picked up one at a time from the floor and thrown gently into the firebox. The charging door was closed, the foreburner was turned on, and the worker went from the room to the hallway. During loading, the charging room door was closed and temperature within the room was 54 C in this test. Data on the sampling plates is shown in Table 13. Recovery of microorganisms during the latter part of the control sample in this test indicates that the contamination was probably caused by carrying the bags into the room and placing them on the floor during control sampling.
